Manhole Inspection Summary

Manhole # S47GG_039MH

Insp Date: **6/18/08 10:27 AM**

Location Address: **Hoffman**

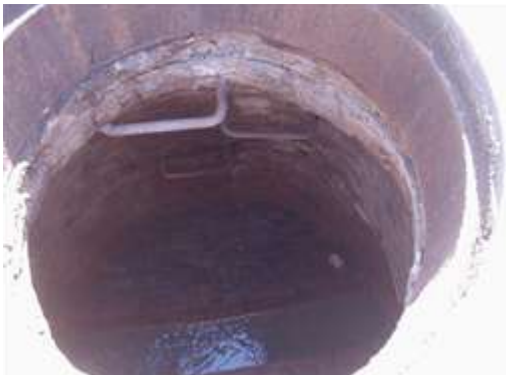
Defect 2

Condition: ☐ Sound ☐ Cracked ☐ Root Intrusion ☒ **Loose Brick** ☐ Deteriorated

loose bricks

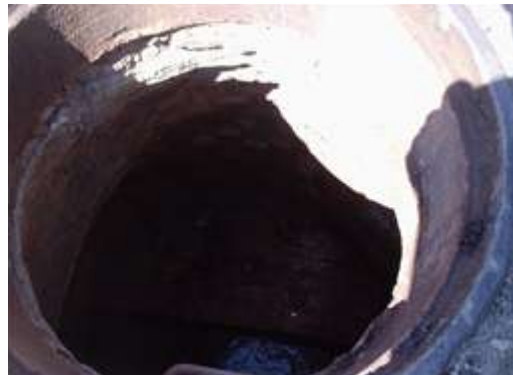
Defect 1

Infiltration: ☐ None ☒ **Joint** ☐ Cracks ☒ **Mortar** ☐ Roots ☐ Wall

infiltration

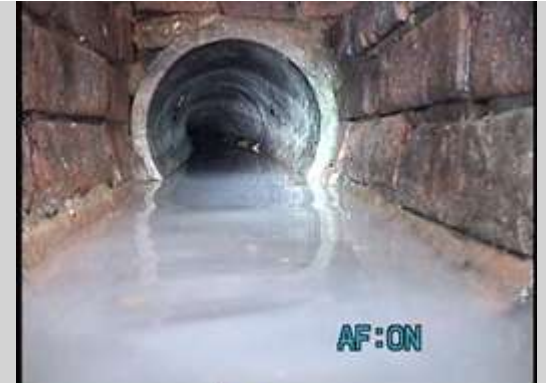
12 O'Clock Outflow

8 in. Circular Gravity Sewer
Pipe Out @ 12 O'Clock

Pipe Height: **8.4** (in.) Rod and Bar (Angled)
Pipe Material: **Clay** ☐ Pipe Lined
Invert Depth: **6.84** (ft.) Flow Characteristics: **Fast**
Deposits: ☒ None ☐ Mud ☐ Sludge ☐ Debris ☐ Grease
Silt Depth: (in.) Deposits Extent:
Infiltration: **None** Pipe Seal Cond: **Sound**

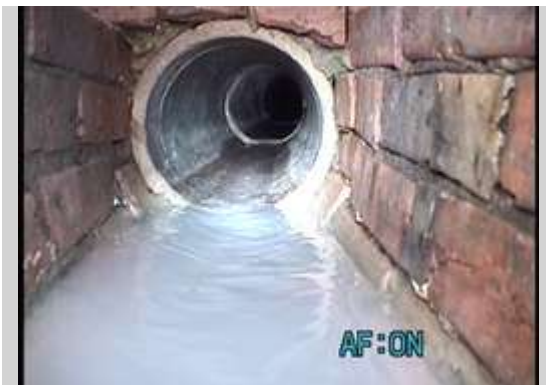
6 O'Clock Inflow

8 in. Circular Gravity Sewer
Pipe In @ 6 O'Clock

Pipe Height: **8.4** (in.) Rod and Bar (Angled)
Pipe Material: **Clay** ☐ Pipe Lined
Invert Depth: **6.80** (ft.) Flow Characteristics: **Fast**
Deposits: ☒ None ☐ Mud ☐ Sludge ☐ Debris ☐ Grease
Silt Depth: (in.) Deposits Extent:
Infiltration: **None** Pipe Seal Cond: **Sound**
